# DENISON HYDRAULICS

## VANE TROUBLESHOOTING GUIDE

1 - EN0721 - A 02 / 99 / 5000 / replaces SI - EN175 - A

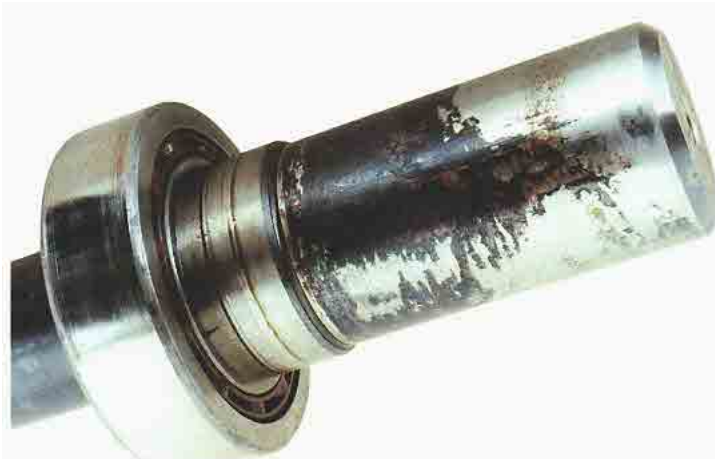
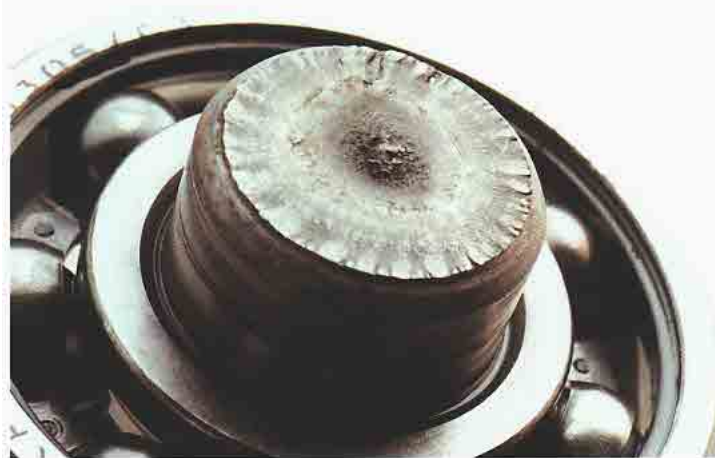
#### II-2-2-1

- Perpendicular, center, rotational bending fatigue rupture.

#### ROTATIONAL BENDING FATIGUE

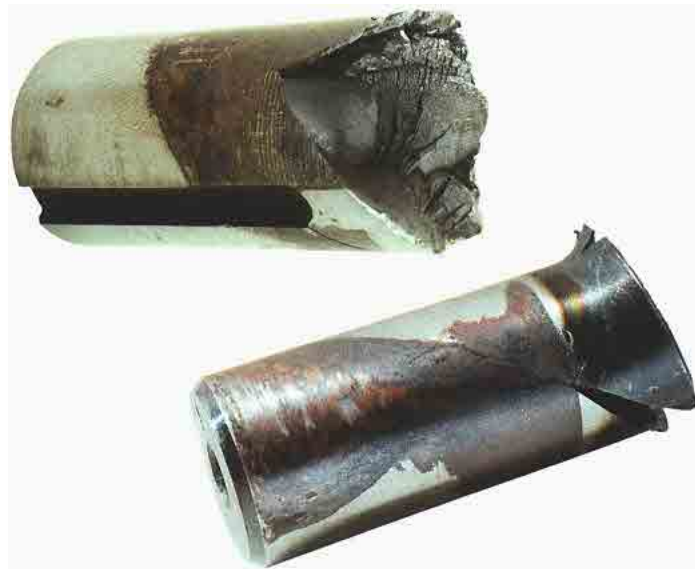
**II-2-2-3 -** Twisted tor-  
sional rupture.

TORSIONAL FATIGUE

- Fretting corrosion  
P 12, II-2-1
- Over torque limits  
P 9, II-1-1-8

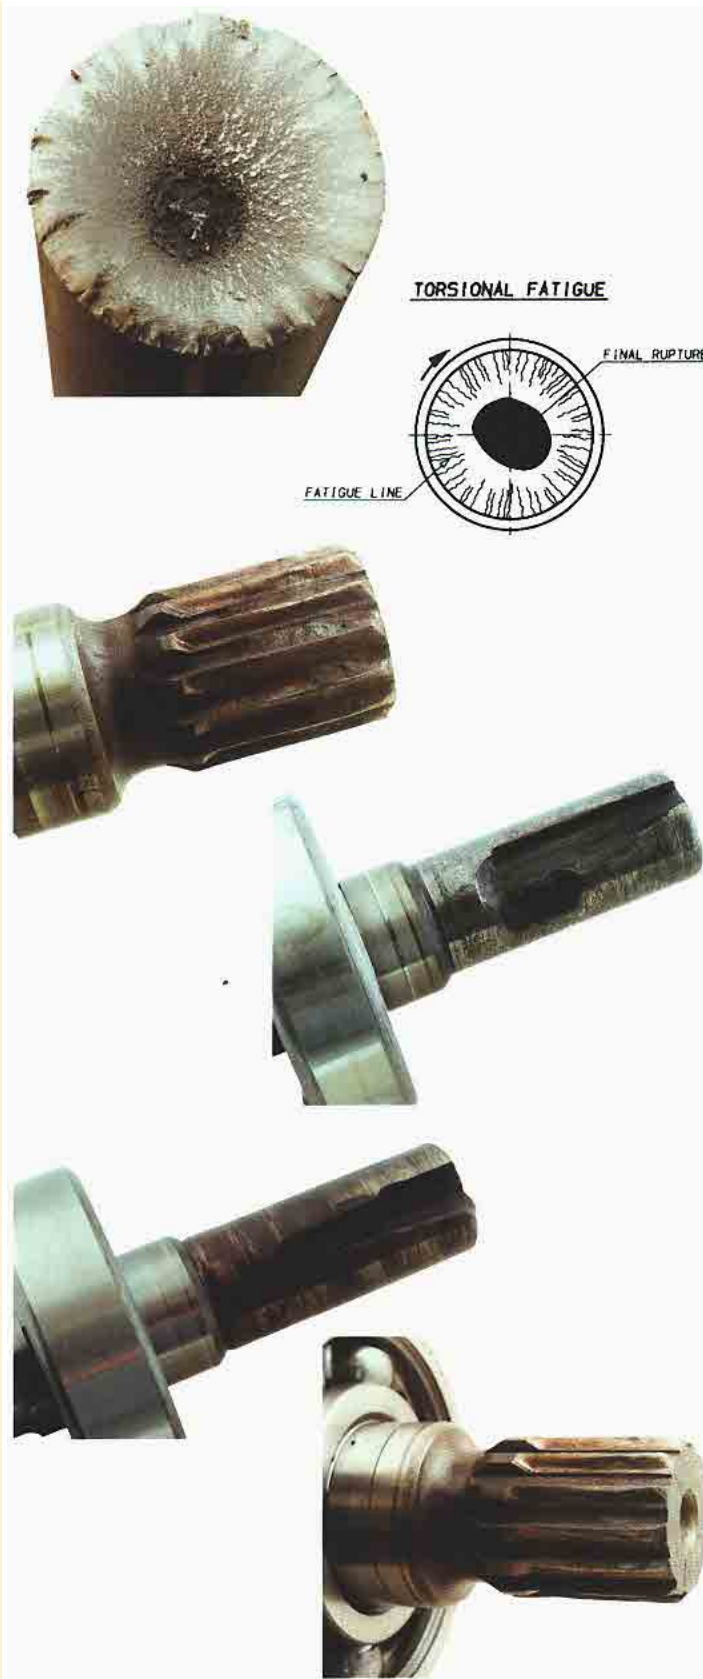
### II-2-2-4

- Perpendicular, torsional fatigue rupture.

- Torsional fatigue with peak torque values  
P 9, II-1-8

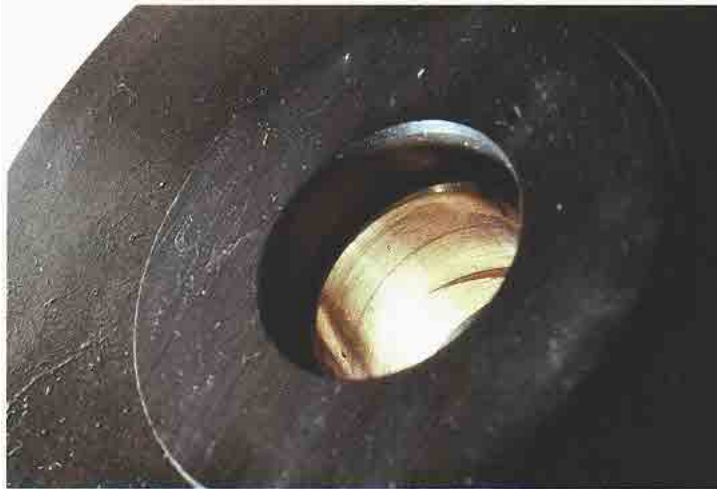
**II-2-5-1** - Front or back bearing/bushing with heavy wear

- Problems on shafts  
P 7, 8, 9, II-1-1
- Bad shaft / coupling connection  
P 9, 10, II-1-2

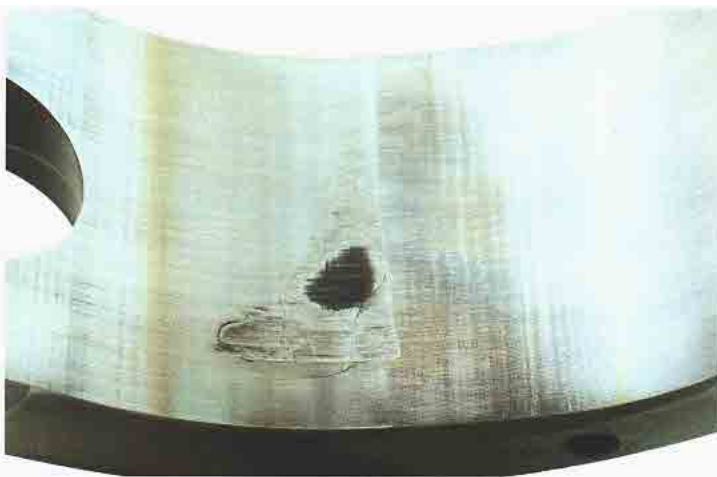
**II-2-6 - Cam ring** **marked** by the rotor on the smallest diameter. If the contact between the rotor and the cam ring is important, it will transform the hardness of the cam ring and create local tensions (cracks).

- Problems on shafts  
P 7, 8, 9, II-1-1
- Bad shaft / coupling connection  
P 9, 10, II-1-2

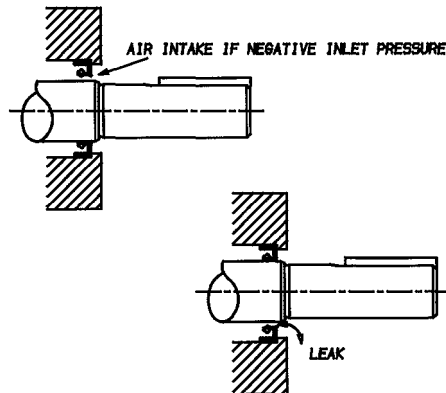
### II-2-7 - Seal loosening

- air intake

- leakage

- Problems on shafts  
P 7, 8, 9, II-1-1  
- Bad shaft / coupling connection  
P 9, 10, II-1-2

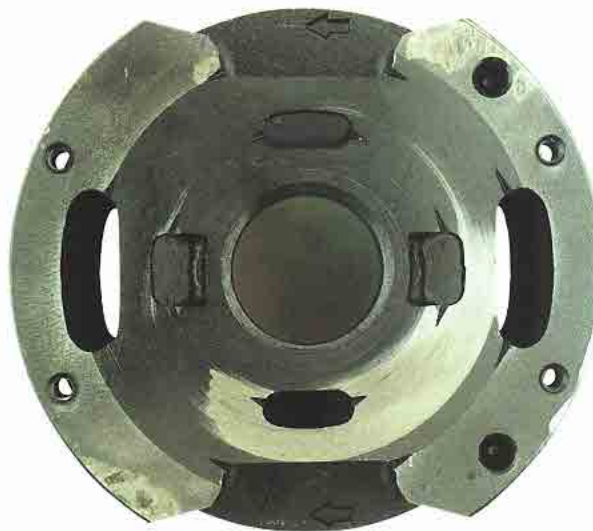
Dissymmetrical  
wear on the side  
plates

- Problems on shafts  
P 7, 8, 9, II-1-1  
- Bad shaft / coupling connection  
P 9, 10, II-1-2

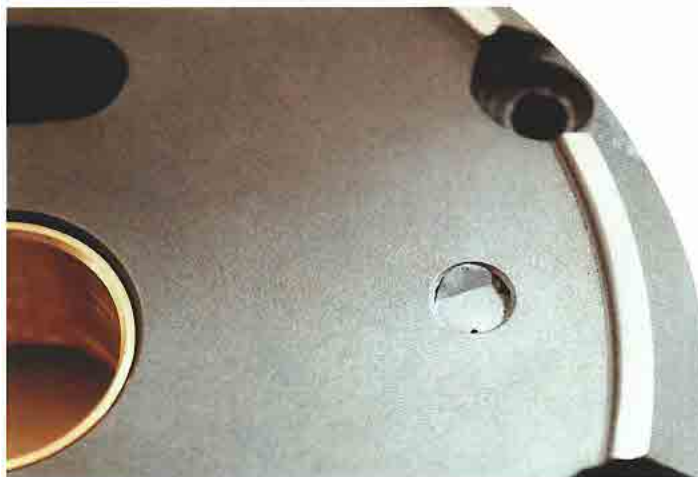
### II-2-9 - Dowel pin broken

- Over torque limits  
P 9, II-1-8  
- Cartridge not properly mounted  
in the housing P 10, II-1-3

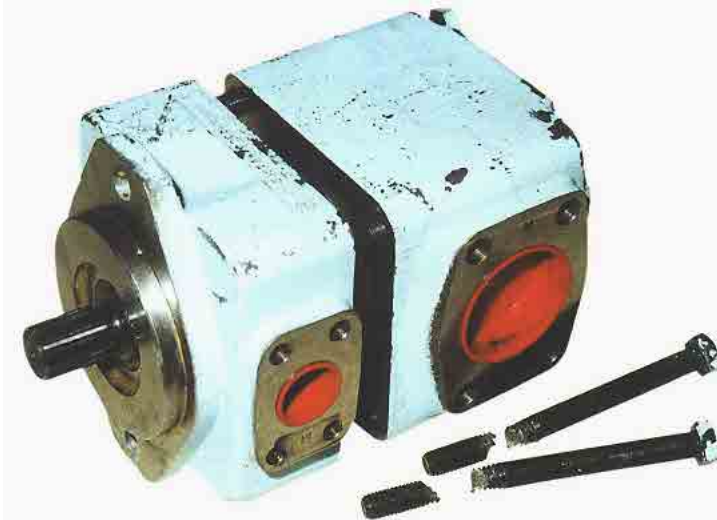
### II-2-11 - Broken screws

- Loose pump fasteners  
P 11, II-1-6

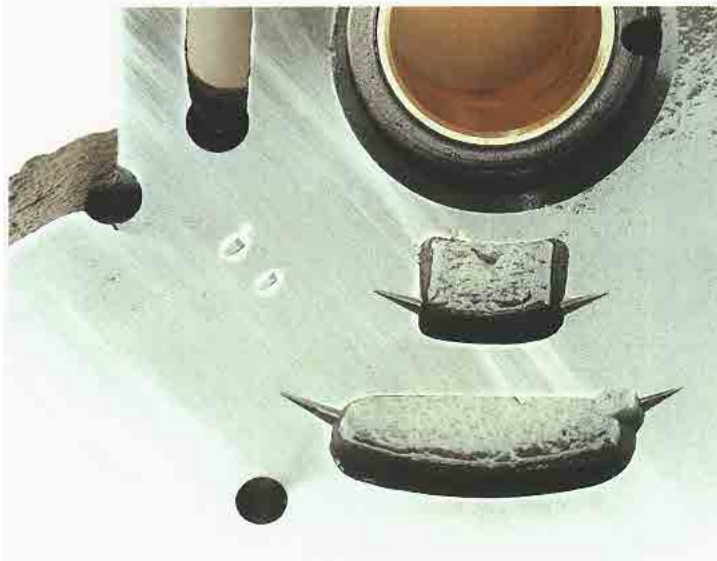
### II-2-12 - Parallel marks on the port plate (vane marks)

- Cartridge not properly assembled P 11, II-1-4

- Tilted vanes marked the port plate but the pump did not rotate.

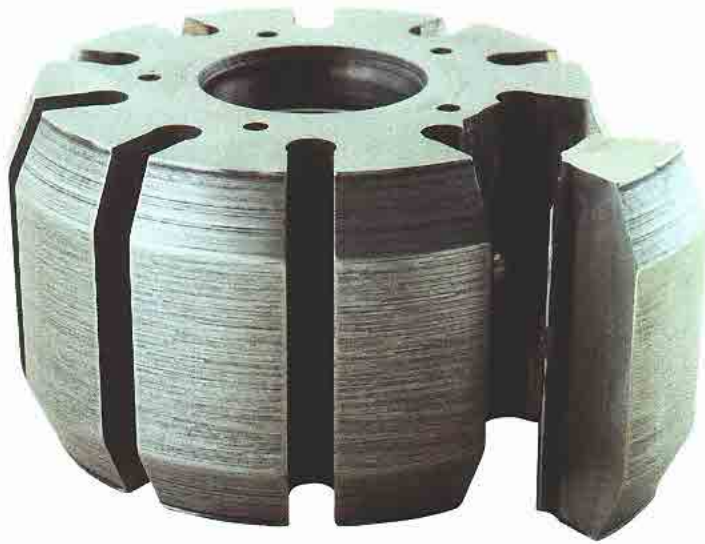
**II-3-3-2** - Cracks or rupture of the rotor

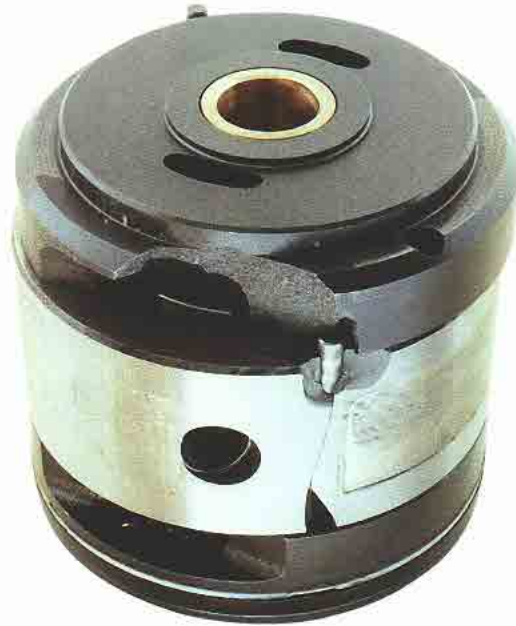
**II-3-3-3** - Cam ring cracked

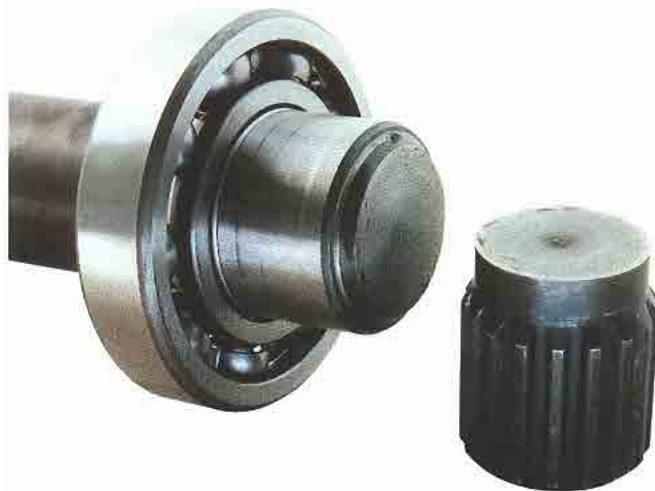
**II-3-3-4** - Shaft broken: perpendicular "clean cut"

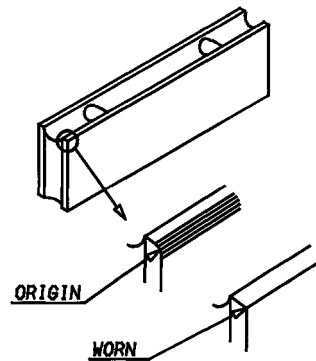
### II-3-5-1 - Vanes

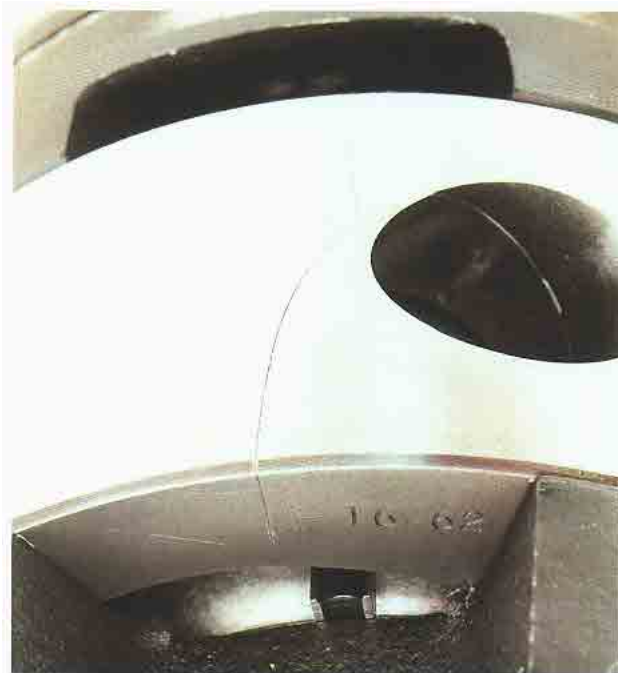
### II-3-7-1 - Cam ring fatigue rupture

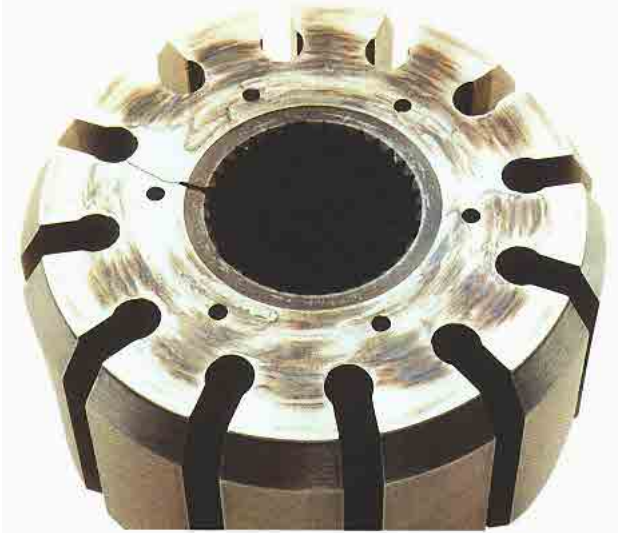
**II-3-7-2 - Rotor/side plates seizure:** This is due to a very strong cavitation when the pressure decrease is dramatic. The sudden flow required is so important that the instant local velocity rises and creates the cavitation.

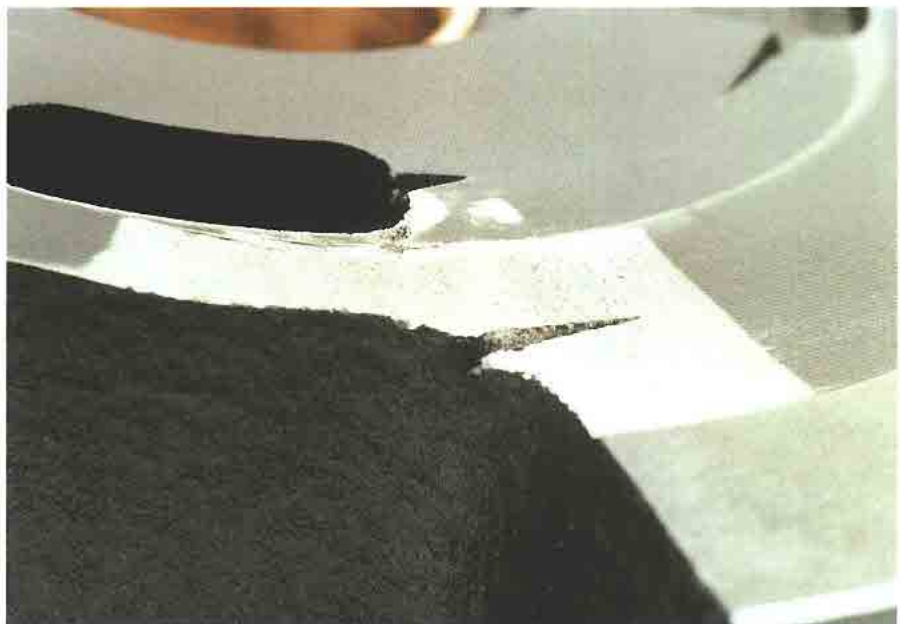
**II-4-2-2-1** - If the quantity of air is erratic or not too heavy, the effects are scores only on the port plates in the suction area

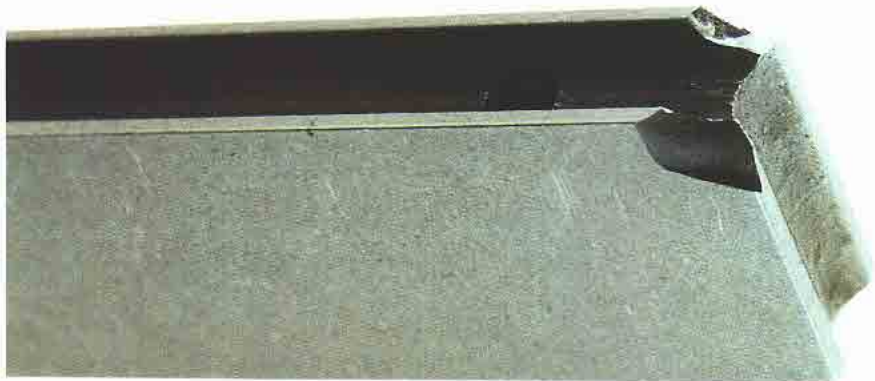
**II-4-2-2-3** - In very heavy air conditions, the vane is so unbalanced that it can even sometimes break (itself).

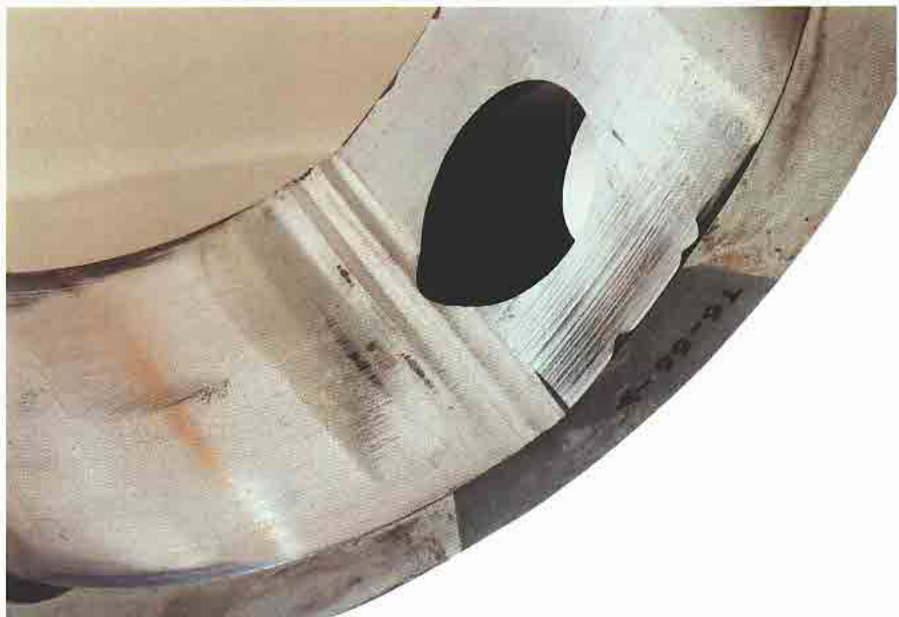
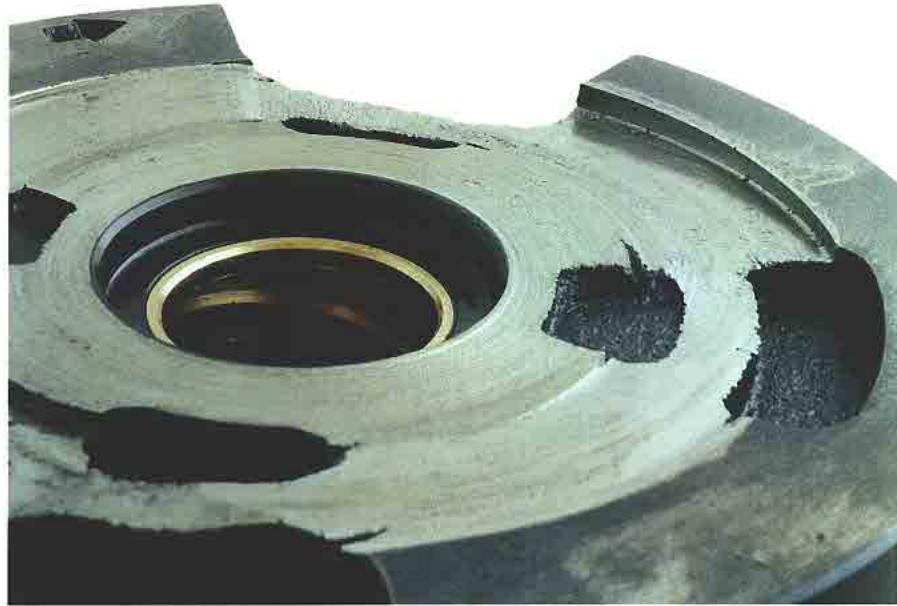
**II-4-2-2-4** - Noisy

Before obtaining such a disastrous wear, the vanes being so unsteady will make a lot of noise, the flow will not be the one required and/or the

pressure level will not be obtained. The physical aspect of the oil will be "milky" on the surface as the oil and the air create a foam.

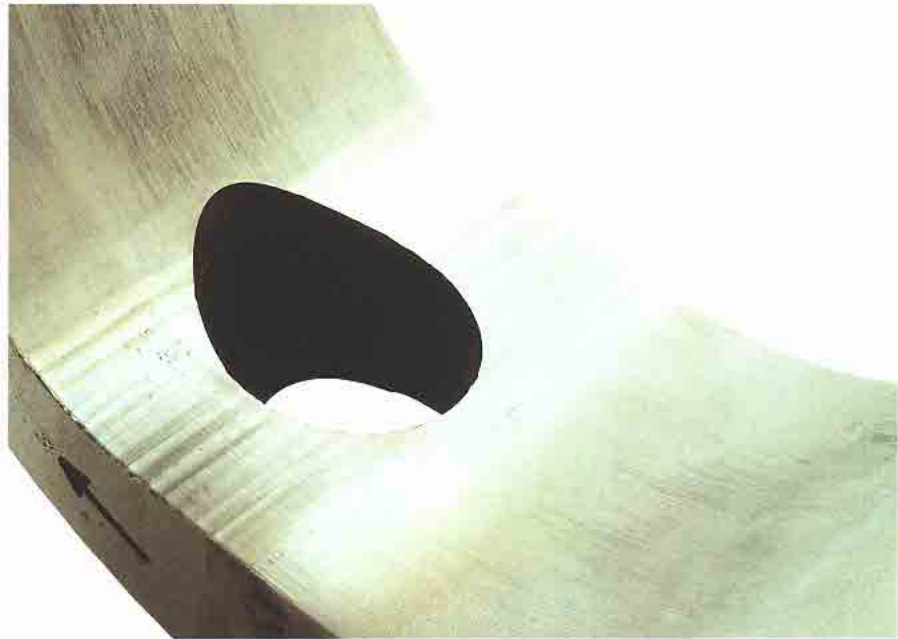
**II-4-2-4-2 - Ripples on the cam ring:** the vanes are hydrostatically balanced to avoid excessive loads on the vane lips. Under suction cycle, the pin compensates the out of balance load due to the cam profile. When the depression is over the design limits, the vane bounces, creating ripples on the cam ring profile. The depth of these marks is proportional to the strength of the depression.

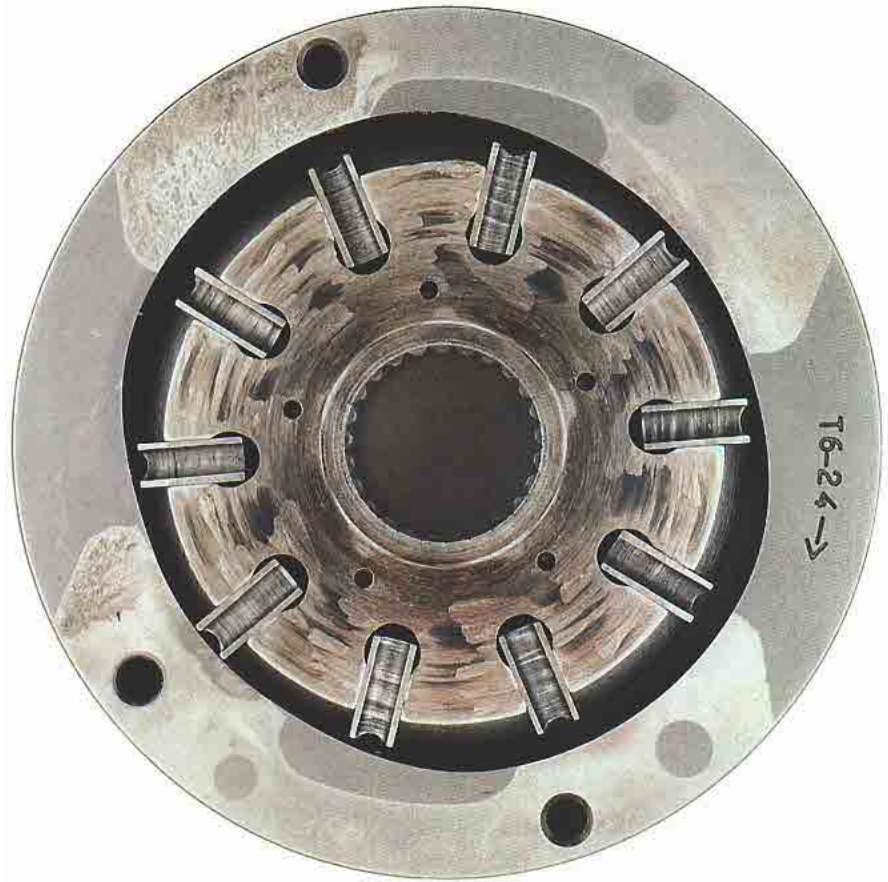
Due to a lack of fluid, the vacuum generated, when really severe, will suck the oil on the side of the pump (between the rotor and the side plates). This will have the effect of breaking the film of oil that lubricates these surfaces. The surfaces will then heat-up and this local over-heat will modify the standard lubricity into a dry friction. The result is a seizure between the rotor and the side plates. (This heavy contamination coming from the digging of craters, the particles can also badly lubricate the pump and lead to the seizure.)

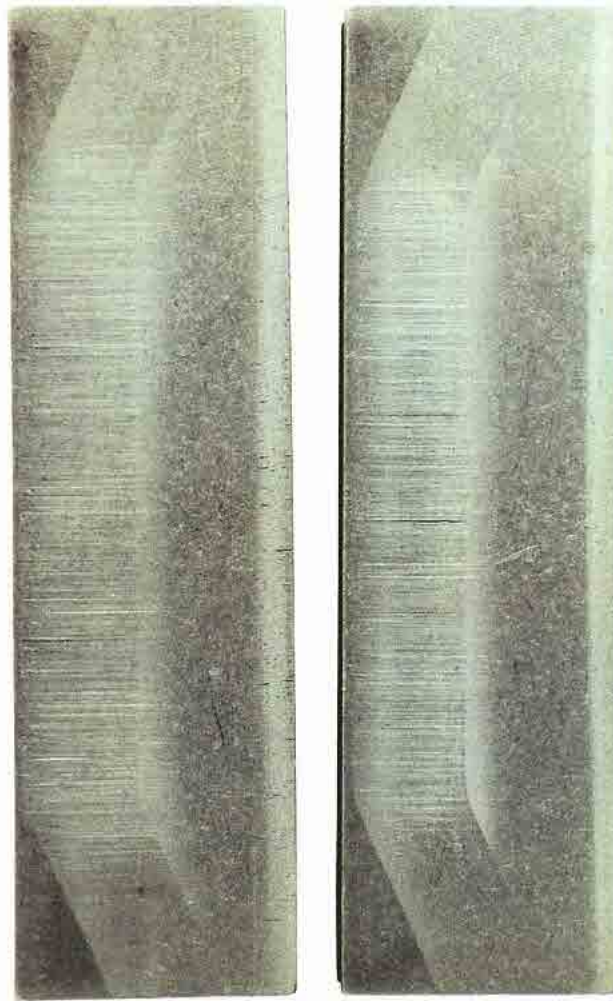
- The vane surface. The film of oil between the vanes and the rotor being contaminated, there will be a rubbing effect in this area. These rubbing marks (pollution marks) will be vertical and of the height of the vanes' translation (displacement).

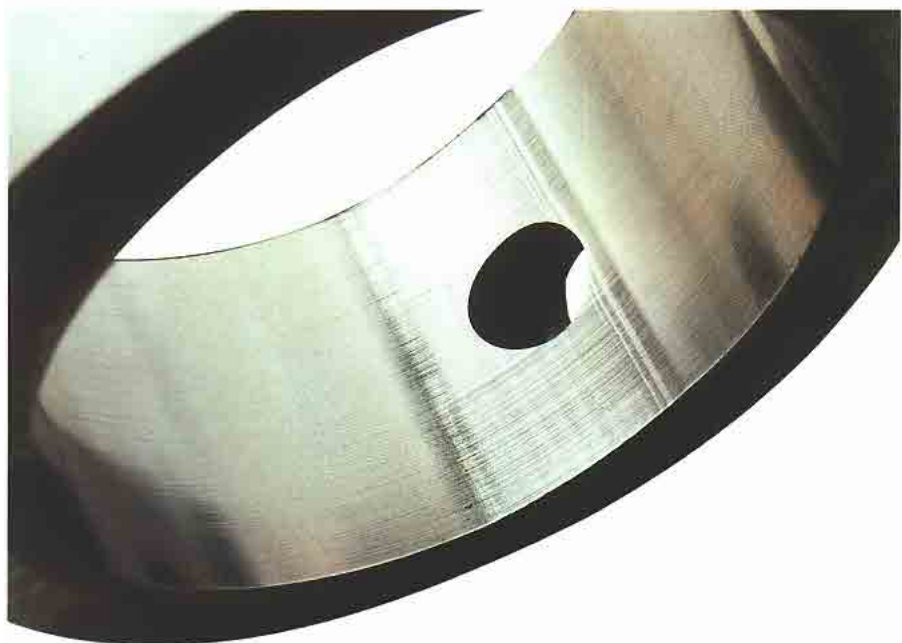
### II-4-4-2 - Cam ring:

- Between the vane lip and the cam ring, the film of oil is contaminated. This will wear the inner surface of the cam ring.

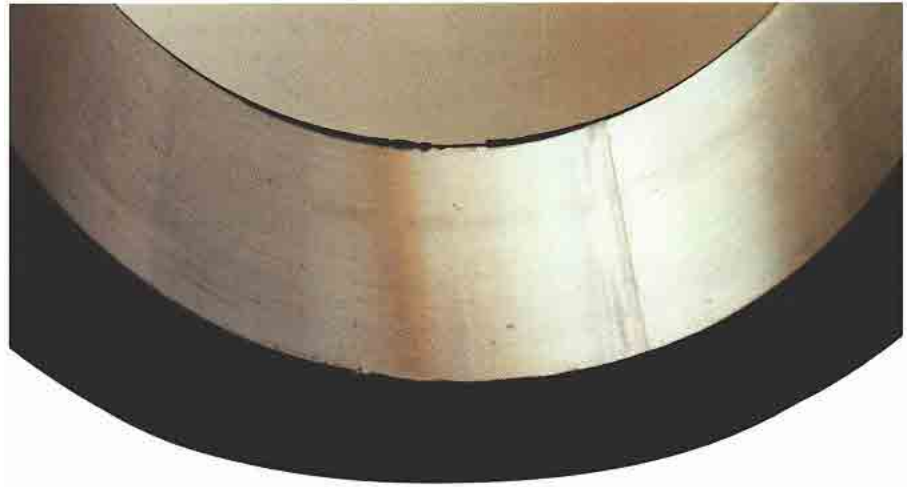
- On the edge of the cam ring contour, (with a slight chamfer when new), you will find a sharp angle (edge). If the wear is heavy, the cam ring can have little burrs in this area.

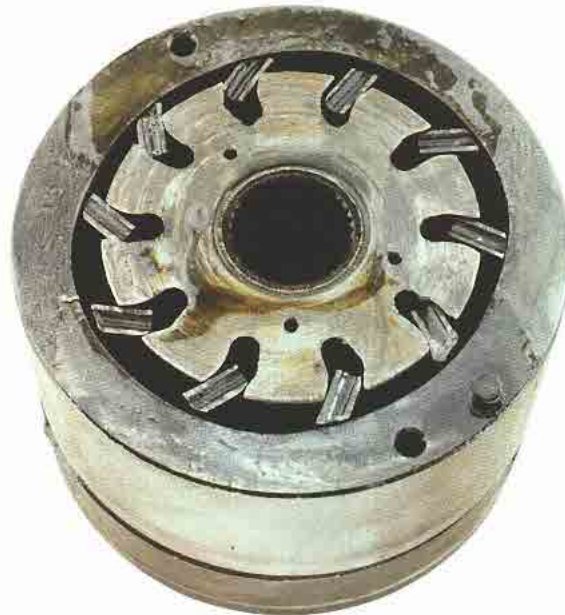
### II-4-4-3 - Rotor/vanes:

In the rotors' slots, the rubbing wear between the slots and the vanes will also lead to vertical pollution marks. (P 32 II-4-4-2 b)

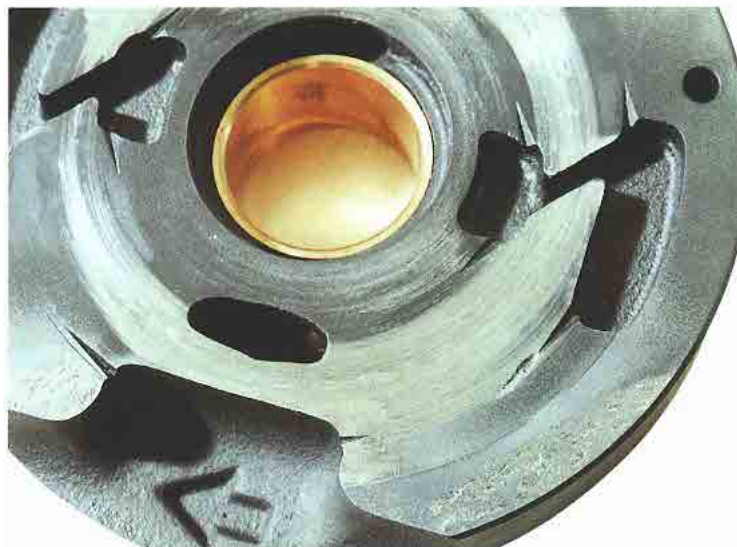
### II-4-4-4 - Rotor/side plates:

When the particles in suspension in the fluid are greater than half of the clearance between the thickness of the rotor and the thickness of the cam ring, seizure occurs in the peripheral diameter of the rotor and the port plates.

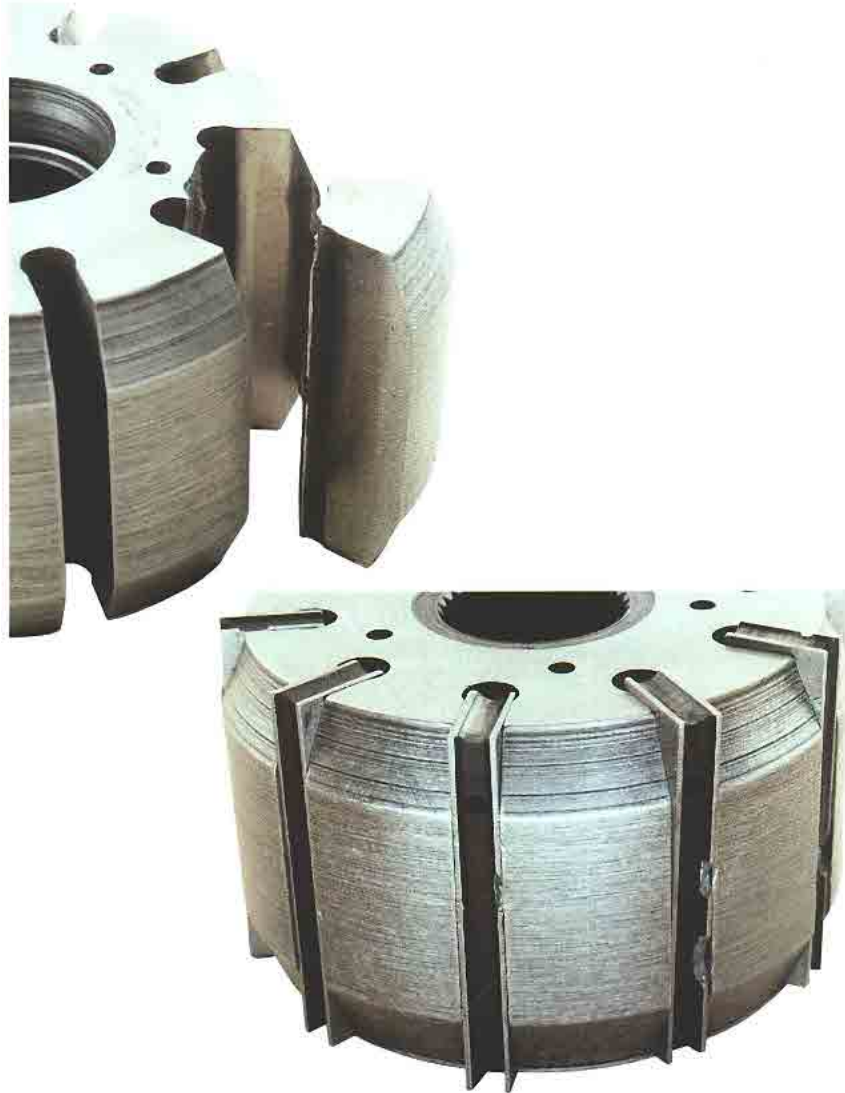
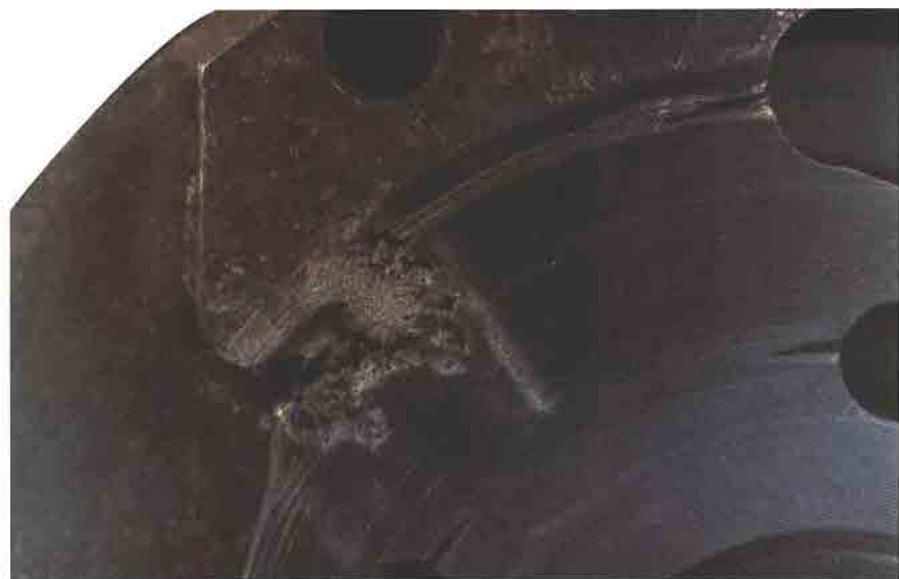
**II-4-4-7 - Side plates:** Another sign of contaminated oil is some possible erosion craters on the port plates at the inlet/suction bleed slots area. These erosion craters would come from the abrasive fine particles in a local high velocity area.

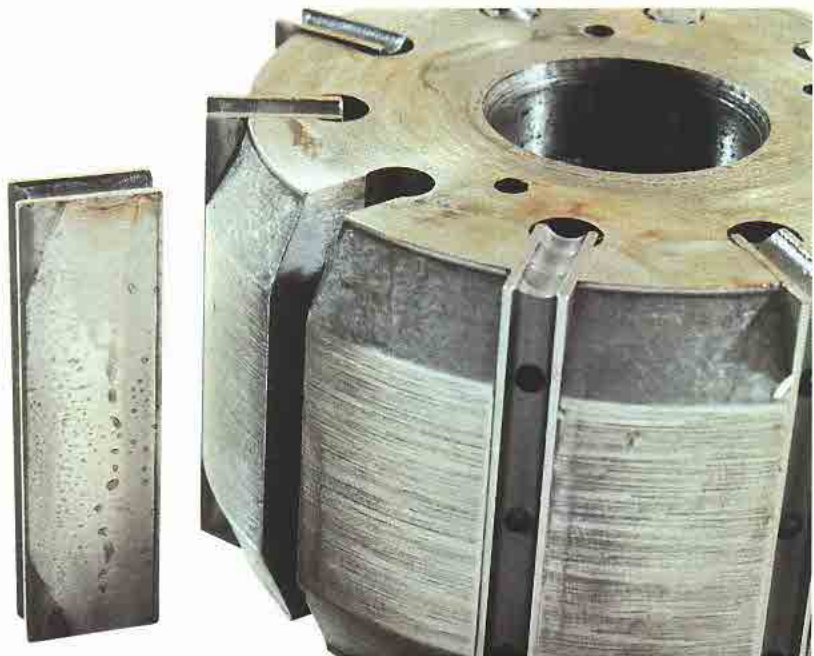
**II-4-6-2** - The fluid can produce foaming because of the steam. The specificity of the foaming oil due to water is a milky or creamy typical aspect. The consequences are identical to the aerated fluid.

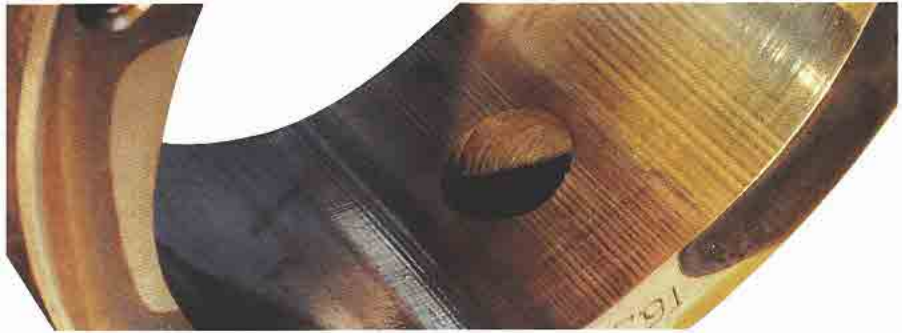
**II-4-6-3** - The fluid compressibility will fluctuate and therefore destabilize the vanes. This will be seen on the cam ring surface full of ripples and on the sharp vane lips edges. In this case, the noise level will be high and the flow & pressure capabilities deteriorated.

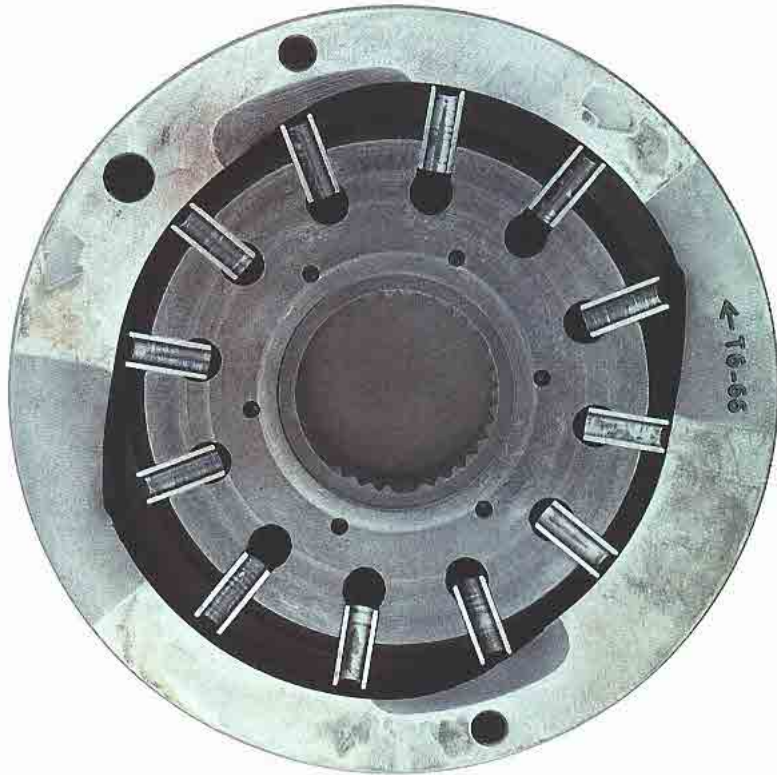
**II-4-6-4** - Due to these fluid transformations, the mechanical consequences go from performance being deteriorated to the destruction of the pump if the local temperatures are extreme (Here, phosphate oil additive deposit).

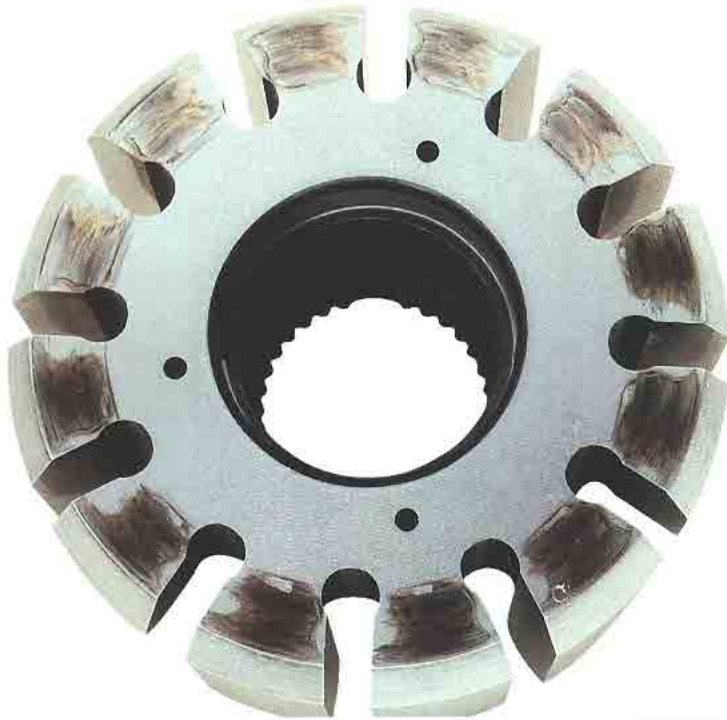
- Seizure due to the high cavitation not allowing the rotating group to be lubricated.

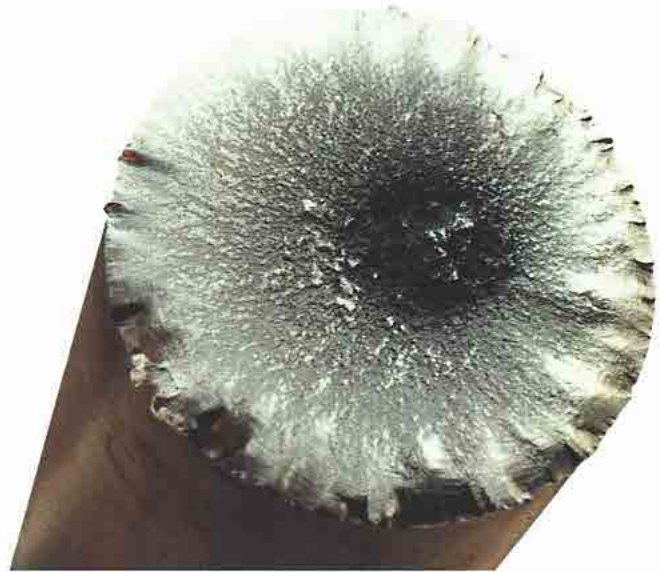
Front shaft rupture

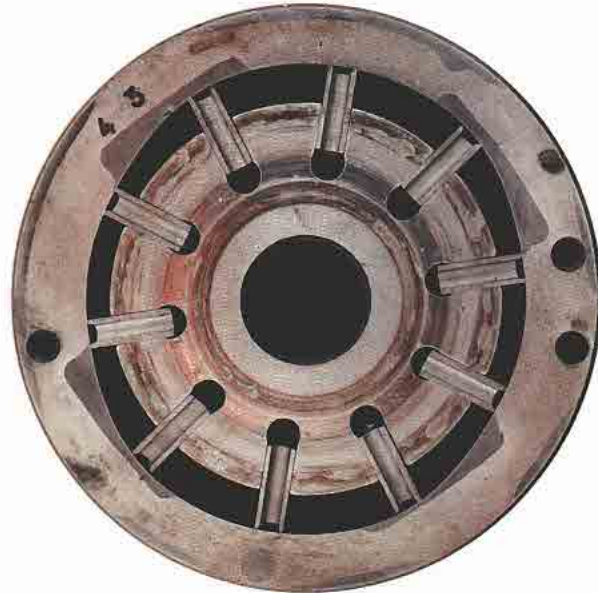
or air intake = incorrect rear cover lubrication. Possible seizure between the rotor and the rear cover.

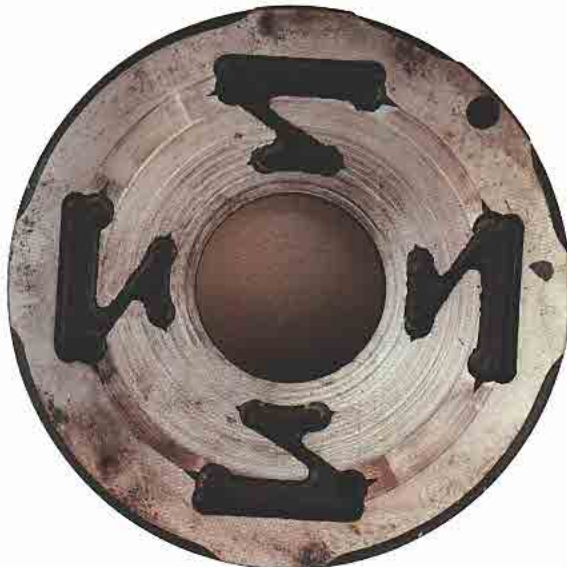
**III-6-Cavitation:** the speed of the motor is higher than the flow coming to the motor. Heavy cavitation will lead to seizure.

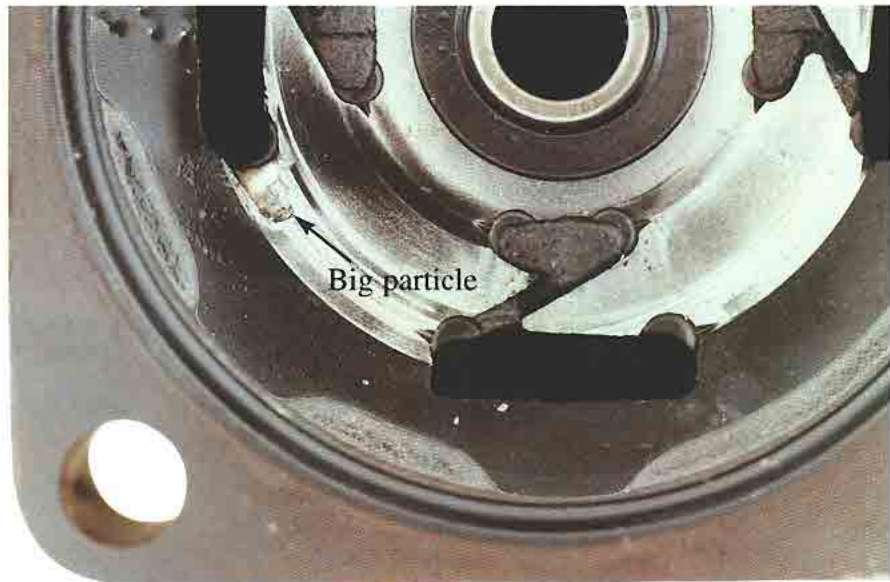
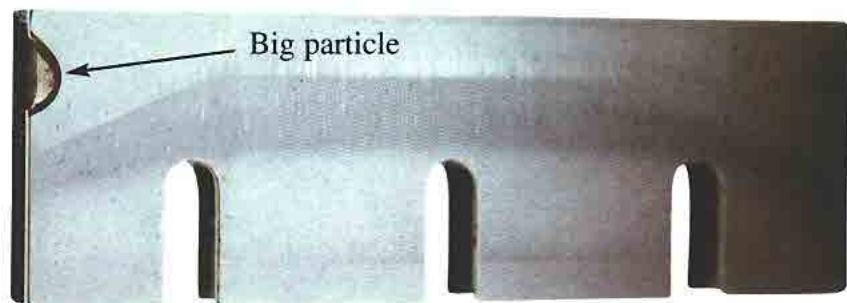
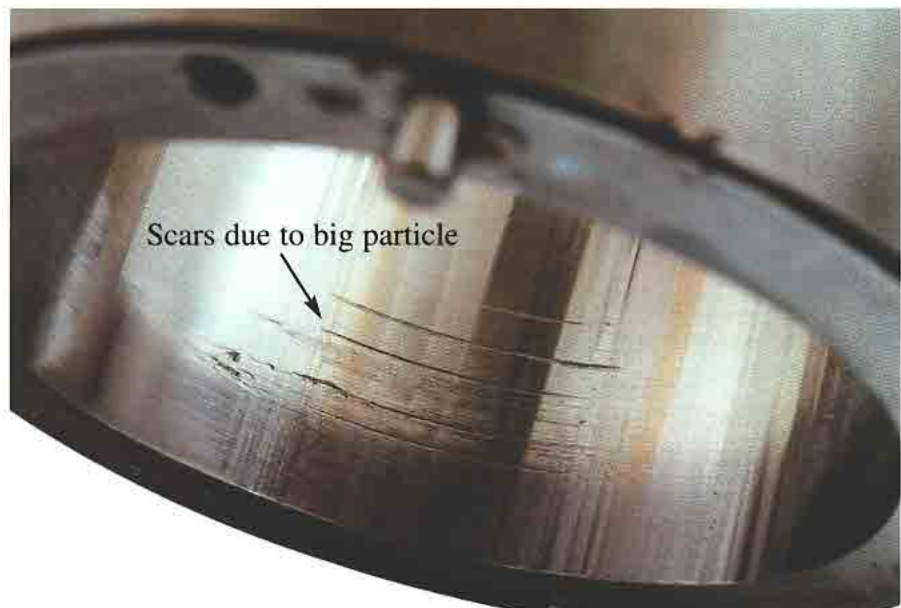
### III-7- Pollution.

- In the rotor slots
  - Grinding on both sides of the slots.
  - Traces of the "spring areas" of the vanes digging in.
- On the side of the rotor / port plates.
- On the vanes  
One big particle (welding ball) and small vertical scars.
- In the came ring  
(Scars due to big particles).

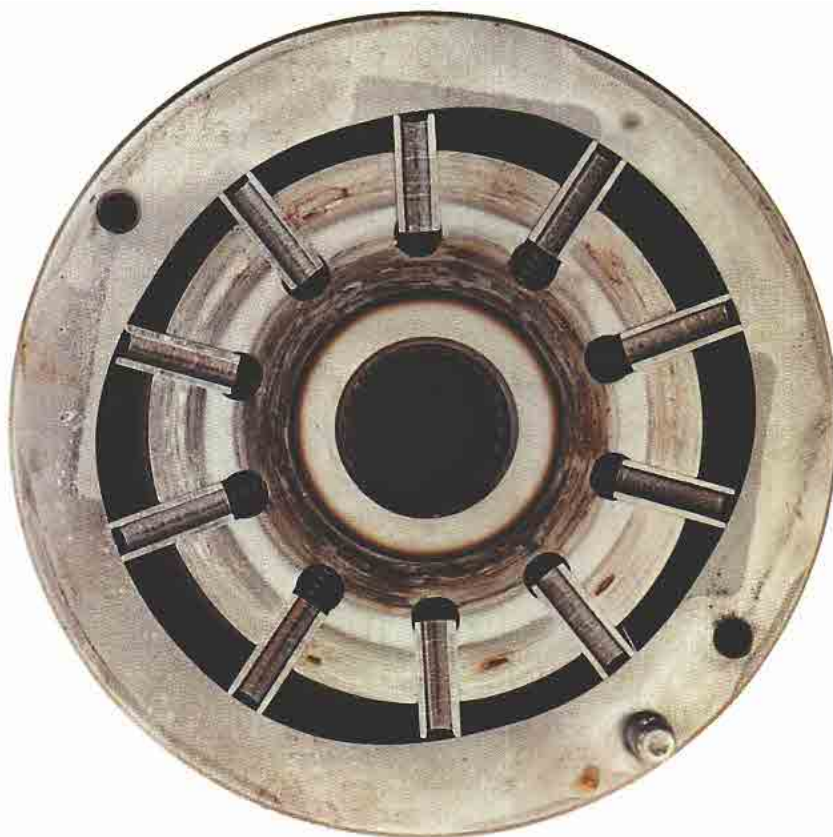
### III-8- Too low viscosity:

If the temperature rises and the fluid becomes very "liquid", the film of oil required to lubricate the components is going to be too thin. This can lead to micro-seizures and to a total seizure if this film of oil is minor.
