# DENISON HYDRAULICS

## VANE TROUBLESHOOTING GUIDE

1 - EN0721 - A 02 / 99 / 5000 / replaces SI - EN175 - A

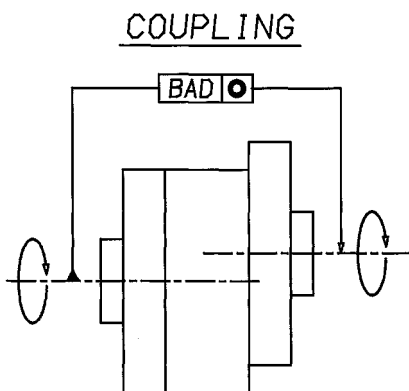
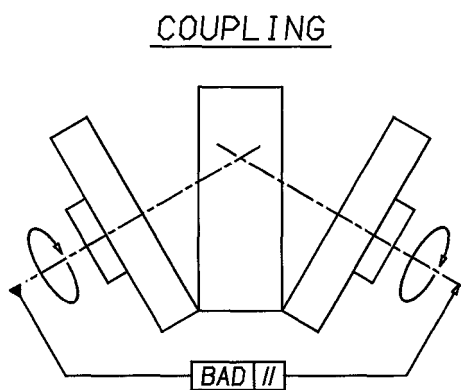
shafts: bad alignment, bad mechanical link (bracket, chassis deformation, bad bell housing, too loose damping elements...) can create:

a) misalignment

b) out of squareness

- Fretting P 12, II-2-1
  - Shaft rupture P 12, II-2-2-1  
P 13, II-2-2-2
  - Rear bushing P 15, II-2-5-1  
P 15, II-2-5-2  
P 15, II-2-5-3
  - Cam ring marked P 15, II-2-6
  - Shaft seal problem P 16, II-2-7
  - Dissymmetrical wear on port plate P 16, II-2-8
  - Ball bearing worn or destroyed
- 
- Fretting P 12, II-2-1
  - Shaft rupture P 12, II-2-2-1  
P 13, II-2-2-2
  - Rear bushing P 15, II-2-5-1  
P 15, II-2-5-2  
P 15, II-2-5-3
  - Cam ring marked P 15, II-2-6
  - Shaft seal problem P 16, II-2-7
  - Dissymmetrical wear on port plate P 16, II-2-8
  - Ball bearing worn or destroyed

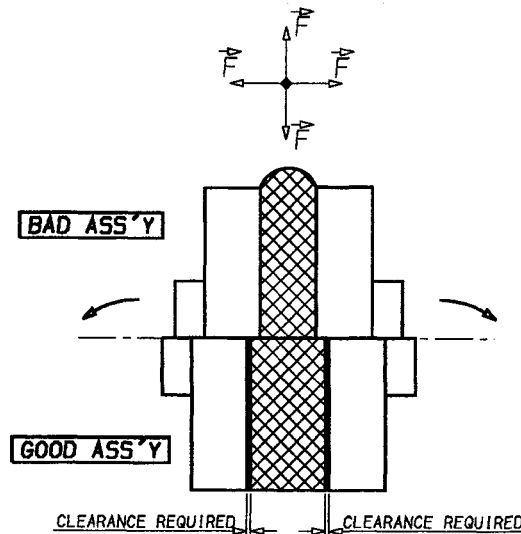
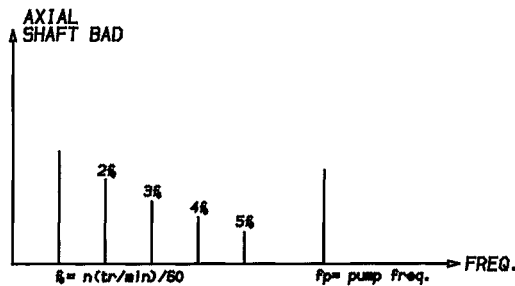
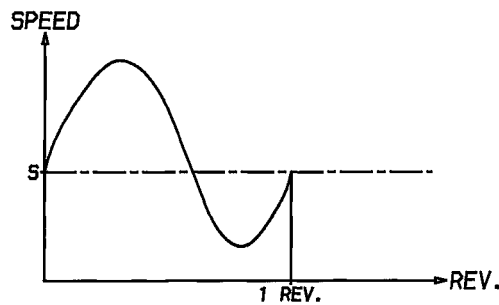
### COUPLING

**II-1-1-5** - Too great moment of inertia due to heavy couplings (like chain couplings) or very large diameter couplings.

- Fretting corrosion P 12, II-2-1
- Shaft rupture P 12, II-2-2-1  
P 13, II-2-2-2
- Ball bearing worn out
- Rear bushing P 15, II-2-5-1  
P 15, II-2-5-2  
P 15, II-2-5-3

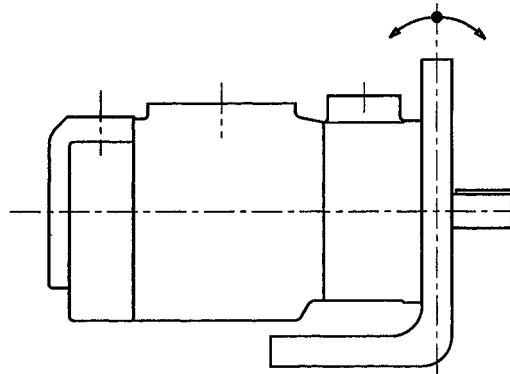
**II-1-1-6** - Bracket chassis deformation (when pump under load).

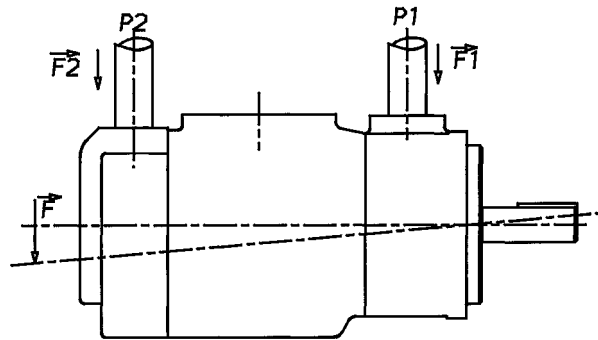
**II-1-1-7** - Hose strain (reaction) force (brutal pressure compression / decompression, rigid hoses mounting strain...).

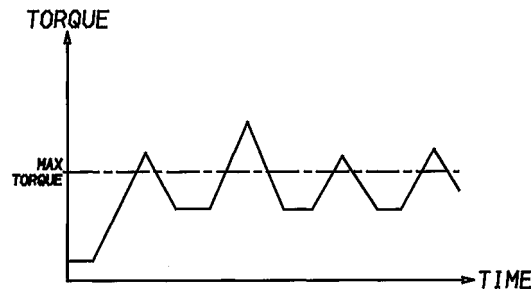
**II-1-1-8** - Over torque limits (too high pressure versus displacement for the capacity of the shaft chosen).

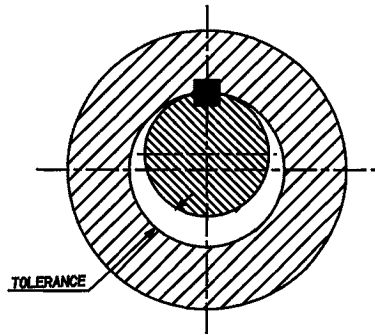
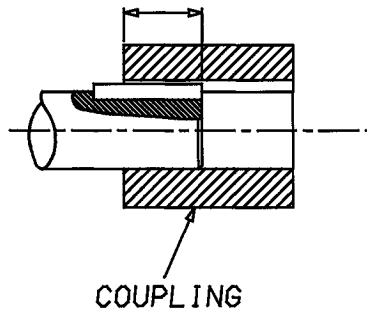
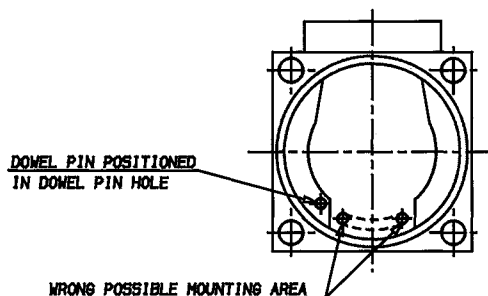
### II-1-2-4 - Bad (or no) lubrication of splined shafts/coupling.

### II-1-3 - Cartridge dowel pin not positioned correctly in the housing.

Denison Hydraulics requires for the lubrication of the shafts a grease with "disulfide of molybdenum" base.

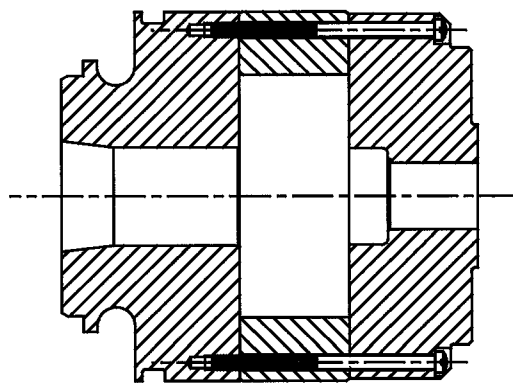
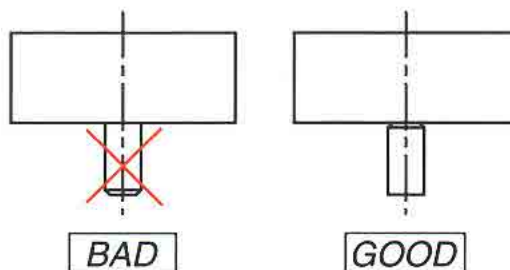
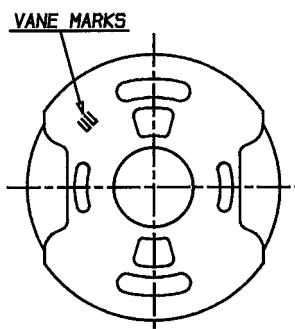
**II-1-6 - Loose pump fasteners** (after modifying the pump, the screws were not tightened at the proper torque and worked loose).

**II-1-7 - Marks on distribution plates** that disturb the cycle of the pump. Even a small scratch between the inlet & the pressure area can destabilize the vane.

- Vane marks P 11, II-1-7
- Vane marks P 17, II-2-12

- Broken screws P 17, II-2-11

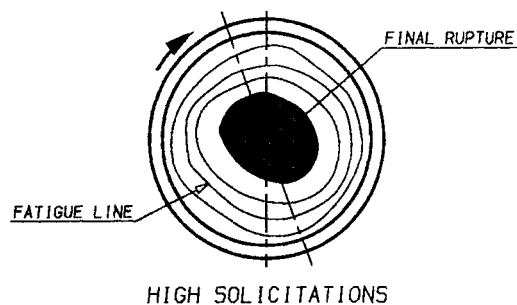
#### ROTATIONAL BENDING FATIGUE

- Bad shaft / coupling link  
P 9, II-1-2-1
- Bad coupling manufacturing  
P 10, II-1-2-2
- Bad grease when assembly

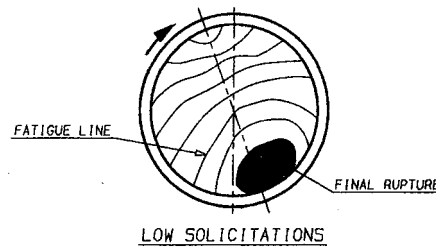
ROTATIONAL BENDING FATIGUE

- Bad alignment P 7, II-1-1a
- Out of squareness P 7, II-1-1b
- Unbalanced coupling  
P 8, II-1-1-2
- Too high radial load  
P 8, II-1-1-3
- Non homokinetic P 8, II-1-1-4
- Too great moment of inertia  
P 8, II-1-1-5
- Bracket chassis deformation  
P 9, II-1-1-6
- Hose strain force P 9, II-1-1-7
- Bad shaft / coupling link  
P 9, II-1-2-1

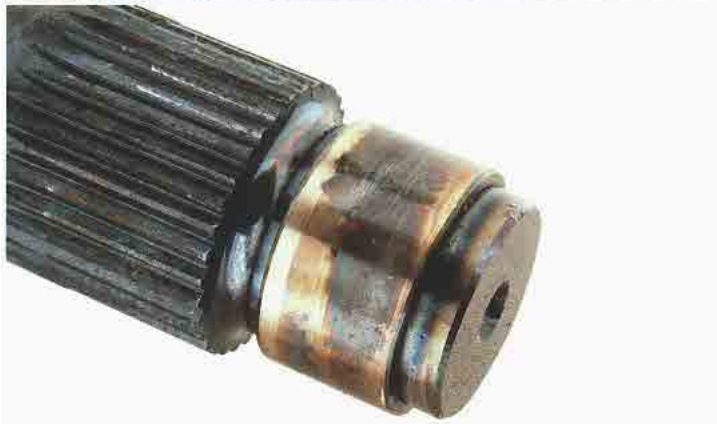
**II-2-5-2** - Bushing "welded" on the shaft

- Problems on shafts  
P 7, 8, 9, II-1-1
- Bad shaft / coupling connection  
P 9, 10, II-1-2

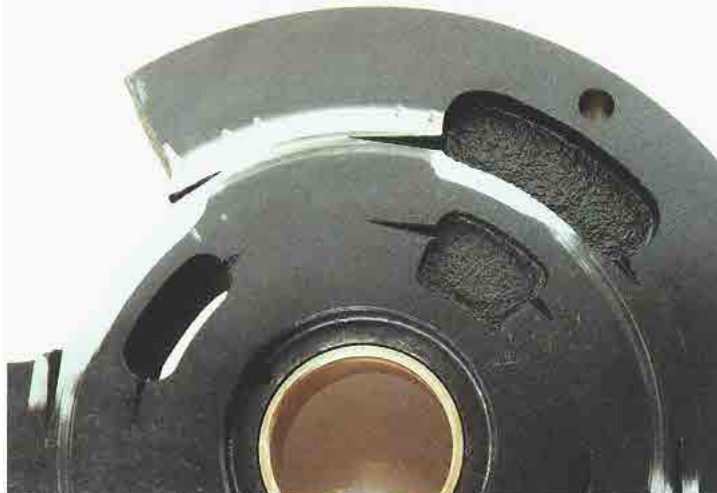
- Cartridge not properly assembled P 11, II-1-4

- Tilted vanes marked the port plate but the pump did not rotate.

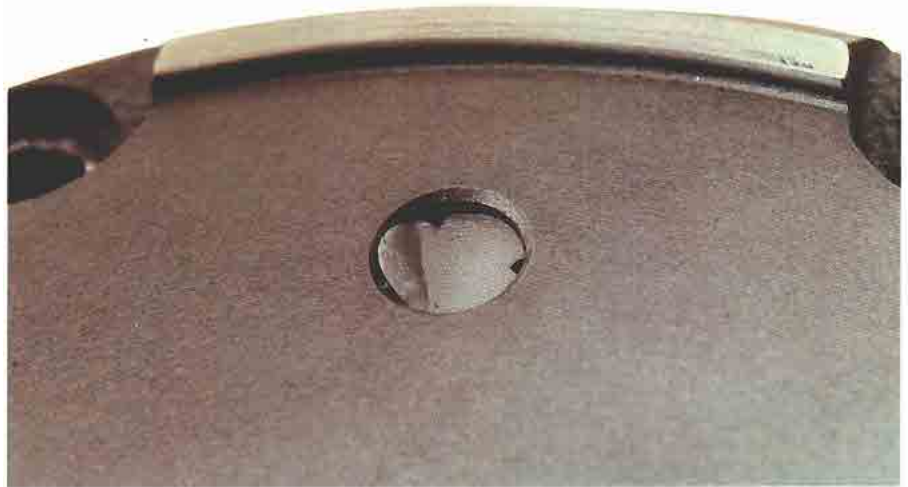
### II-3-3-5 - Dowel pin cut in two

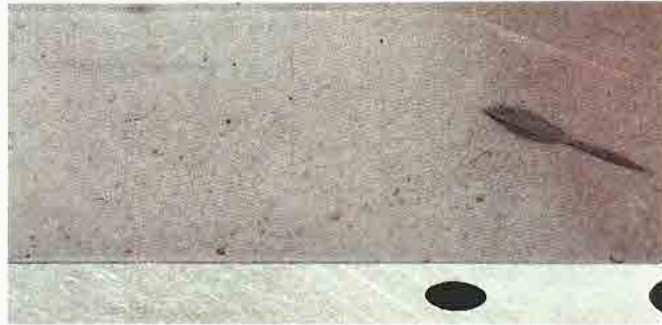
- vanes

### II-4-2-4-3 - Craters (continuation)

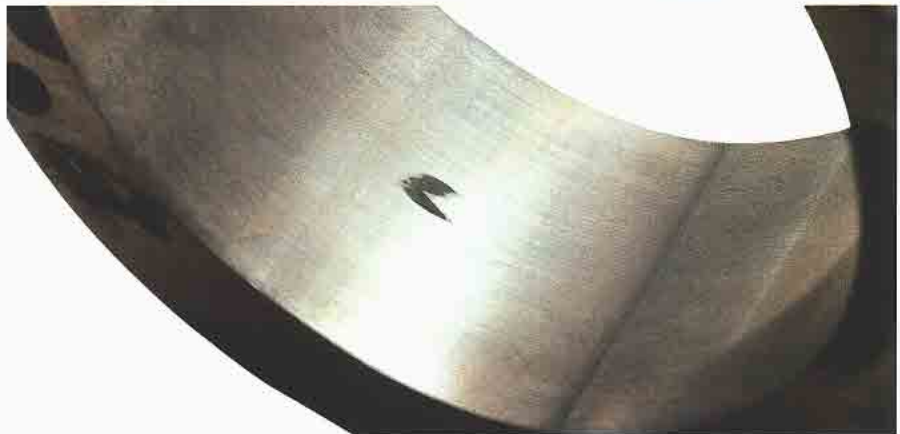
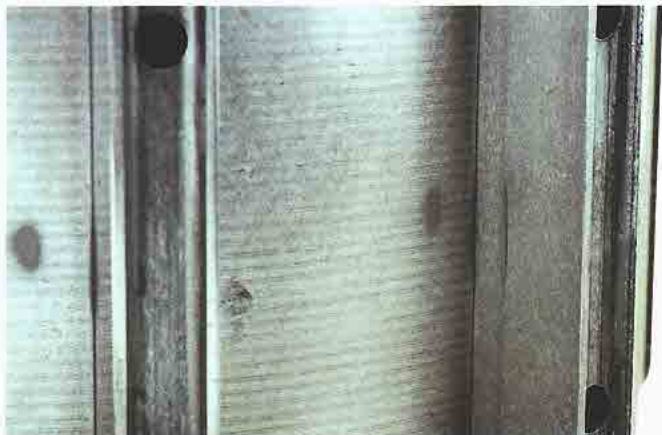
### II-4-2-4-4 - "Black marks":

The local depression consequences can be seen on the vanes (top lips and on the center of the vane), on the port plates (in the inlet area) and on the center of the cam ring (just after the inlet "feeding hole"). These "black marks" can be transformed into small craters in the port plates near the outlet bleed slots as the air bubbles explosion occurs.

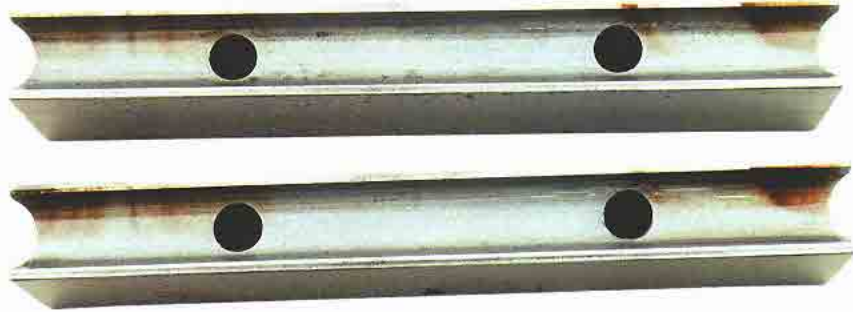
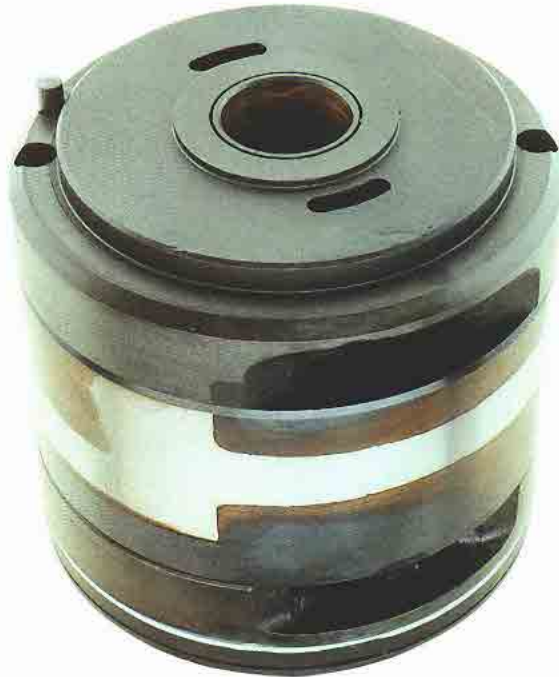
On the cartridge, it changes the colour of the bronze bushing (due to the modification of the acidity) and leaves a deposit on the external diameter.

**II-4-6-2** - The fluid can produce foaming because of the steam. The specificity of the foaming oil due to water is a milky or creamy typical aspect. The consequences are identical to the aerated fluid.
